Testing Building Envelope Systems Using Infrared Thermography

Abstract

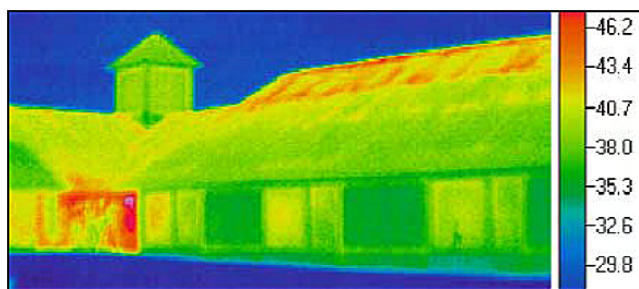
Image 1. Excessive heat loss and poor ventilation resulted in costly ice damage to this large roof.

Often the problems – as well as their causes and consequences – simply cannot be seen until after costly damage has been done. At that point the only recourse may be extensive, costly reconstruction. The commercial building in Image 1, a nursing home, had extensive problems resulting from a poorly designed roof/ceiling insulation system; these included excessive heat loss during the winter months and, as a result, extensive ice damage due to snow melt. Hundreds of thousand so dollars were spend in various, poorly planned attempts to correct the underlying causes. In the end the owners simply lived with the continued problem because corrective actions were deemed too expensive. Despite

this unfortunate resolution, the thermograms helped the owners negotiate a financial settlement with the architects and contractors.

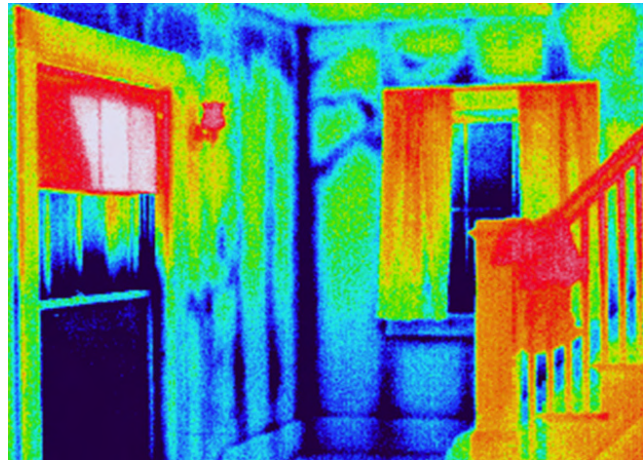
Image 2. When conditions are right, it is possible to locate missing or damaged insulation, such as this poorly installed injected foam in a residential building.

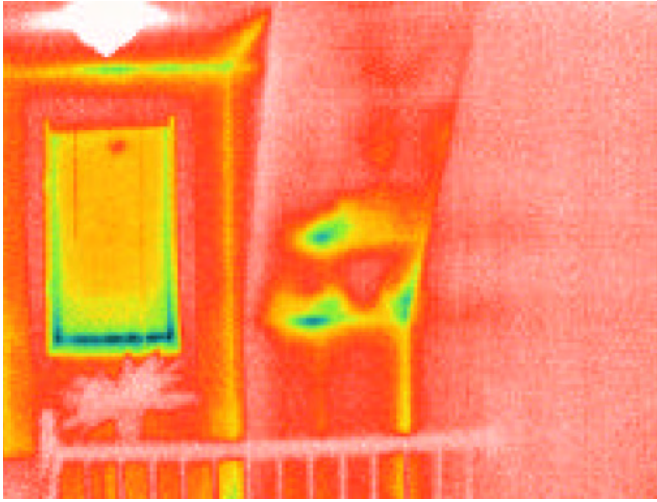
Image 3: The improperly installed fiberglass yields an irregular thermal pattern. The resulting cold spots commonly host wall stains or mold growth.

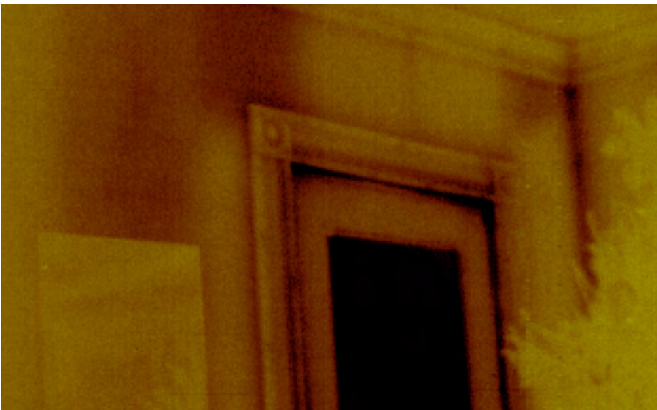
Image 4: Properly installed cellulose is an excellent insulation. Unfortunately, it is often poorly installed with missed areas and settling the most common quality problems.

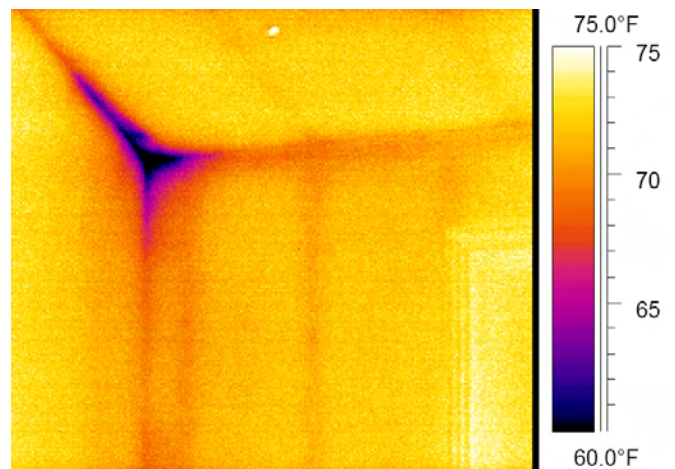
Image 5: Many types of insulation are susceptible to air infiltration. The fiberglass shown here does not stop air flow through the wall section.

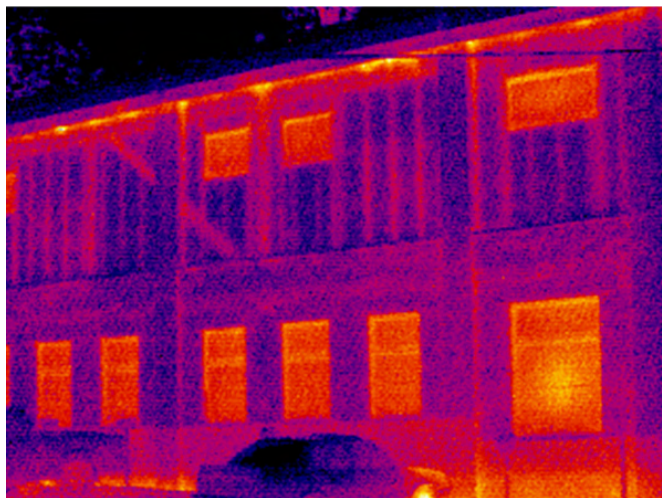
Image 6: All the framing and insulation is clearly visible in this commercial building. Normal pressure differences on the top floor result in air leaking past the envelope through various pathways.

under a pressure gradient. Image 6 shows the impact of warm air leaking out of this commercial building. This will typically go unnoticed until the fuel bill is paid.

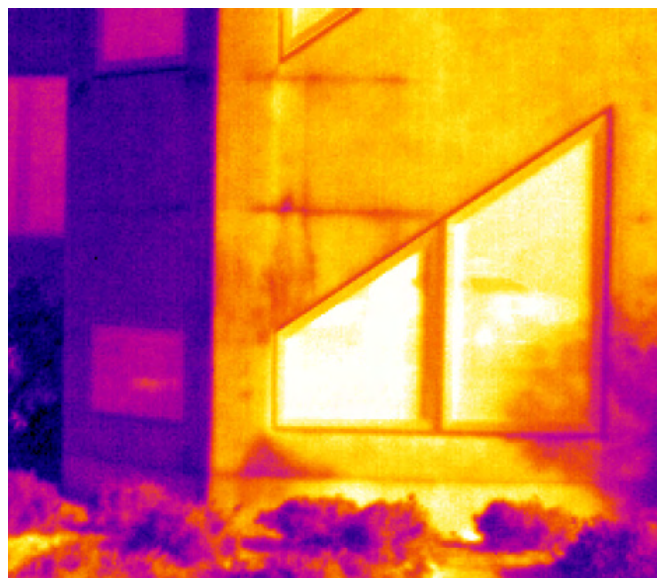
Image 7: EIFS construction is particularly susceptible to water intrusion resulting in both mold growth and wood rot problems.

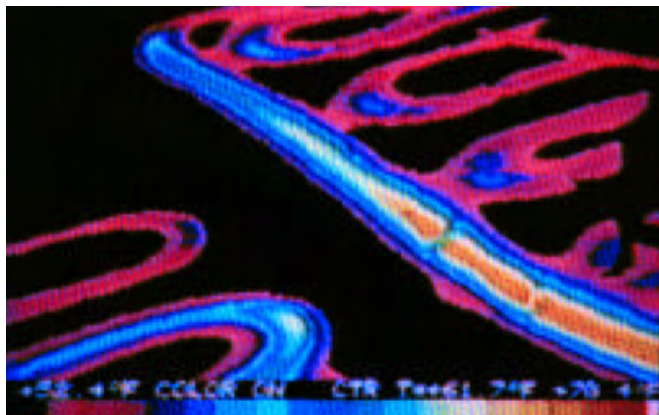
Image 8: Hydronic heating coils embedded in a concrete floor show up in this thermal image.

Heating coils are being used more and more either to keep outside walkways or entrance ramps snow free or to provide heat to areas and rooms via hot water or electric cables. Thermography provides a quick way to verify location and performance of these subsurface devices. Typically the thermal pattern shows up very clearly even when the heat source is embedded in several inches of concrete. Similarly, water pipes in wall sections can usually be located quite readily.

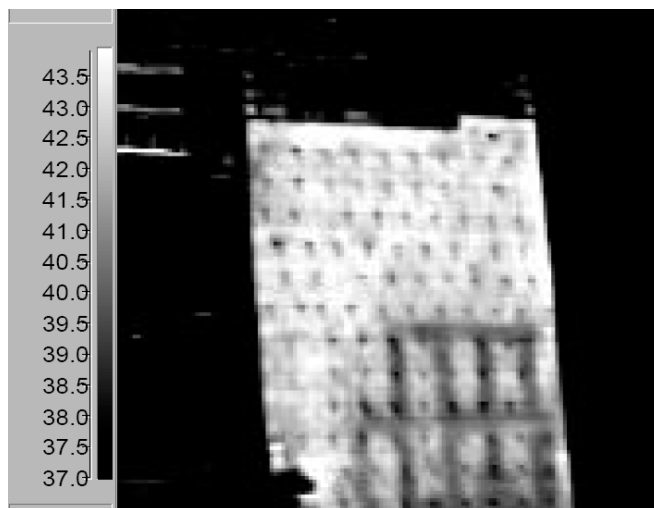
Image 9: This block wall is not uniformly grouted as was specified, leading to severe structural problems. Image courtesy Phil McMullen.

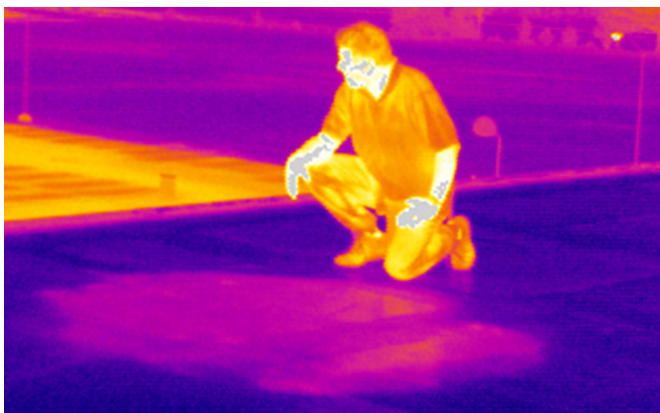
Image 10: The wet insulation in the roof system shows up clearly due to its greater thermal capacitance.

The inspection of flat roofs, especially built-up roofs (BUR) has been proven for a number of years. The technique allows for the detection of moisture trapped in a roof system; over time this moisture leads to the pre-mature degradation of the roof. The moisture appears warmer at night after a sunny day due to its greater thermal capacitance.

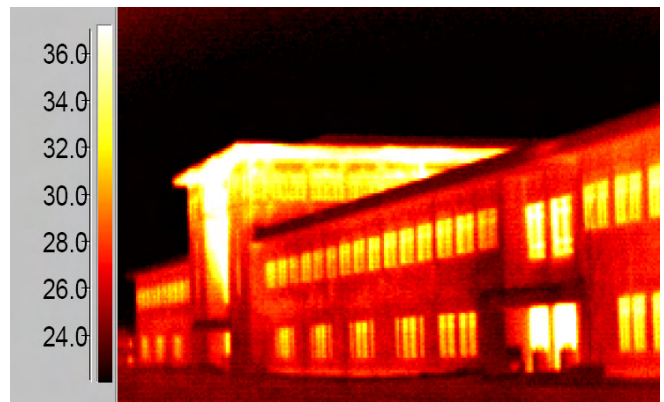
Image 11: During the commissioning of this building thermography revealed an extreme problem involving exfiltration through the soffit. Courtesy Phil McMullen.
